# FLOWING AGAIN AFTER FLORENCE

## Emergency response and recovery at ONWASA's Northwest Regional Water Reclamation Facility following North Carolina's costliest disaster to date

By Jimmy Holland, Project Manager, WK Dickson; and  
Angie Mettlen, Director of Strategic Funding and Regulatory Affairs, WK Dickson

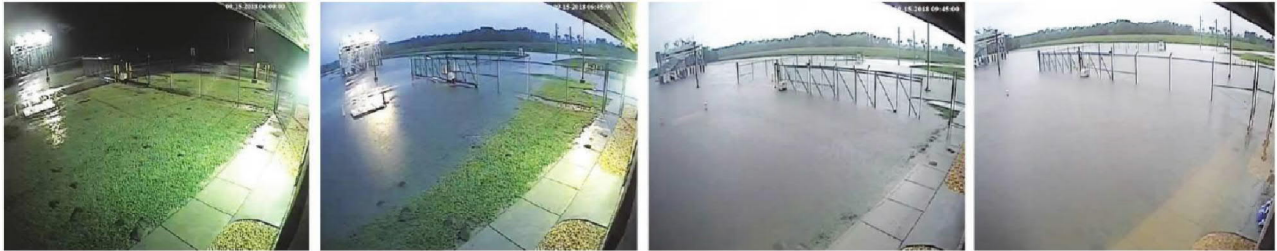
CCTV revealed the advance of rising waters early the morning of September 15. As conditions deteriorated, two operators had to be evacuated by swift water rescue boat.

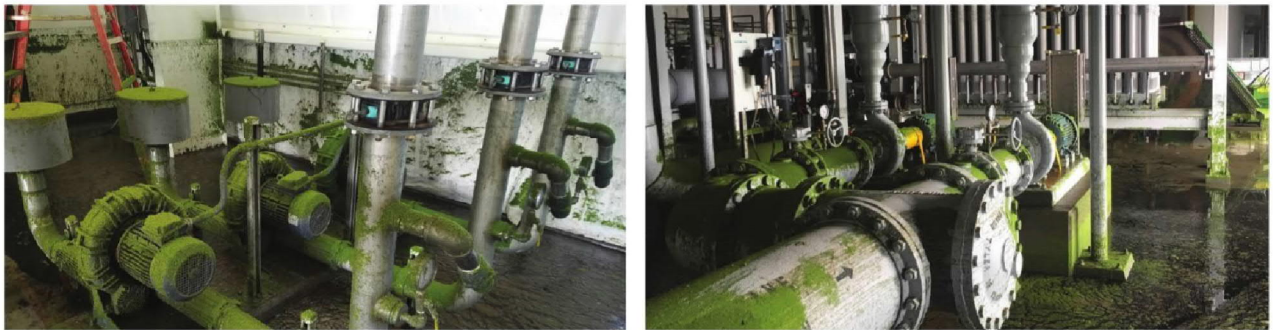
Floodwaters inside the plant reached more than seven feet above the 100-year flood elevation, causing extensive damage and leaving the plant completely inoperable.

During the storm, floodwaters reached a height of 3-4 feet in the facility's electrical distribution and control building, as well as in the filtration and disinfection process equipment building. This was more than 7 feet above the 100-year flood elevation. Although the automatic transfer switch came on and the backup generator remained operational throughout the event, electricity could not reach the equipment. Extensive damage to the pumps, motors, motor controls, and electrical equipment

left the facility completely inoperable. The flooding also caused a bypass of 3.2 million gallons of partially treated wastewater into Cowhorn Swamp. Fortunately, and in large part due to the proactive measures taken by staff in the days prior to the storm, no hazardous chemicals were spilled. Because influent was able to be routed to the five-day upset ponds while the plant was offline, the public served by the plant never lost sanitary sewer service.

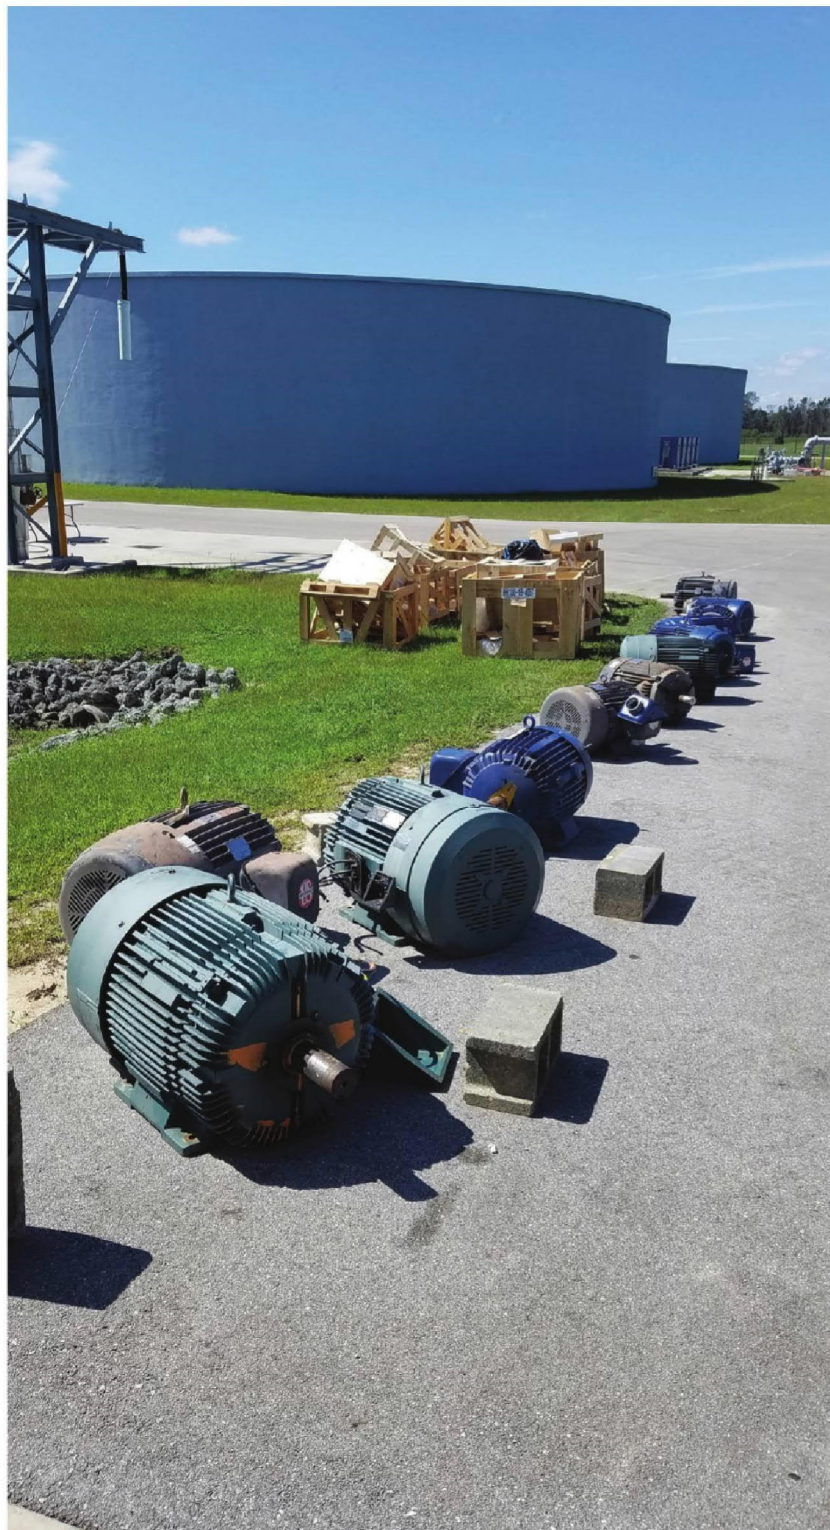
Damaged motors line the yard in the week after the storm.

back on site, a local pump repair shop took some of the pumps and attempted to bake them in an oven for 4 hours to dry them out, but the drives remained inoperable, and they would not fire up. Greenville Utilities Commission staff found a vendor that was able to supply 28 replacement motors. A supplier in Atlanta was found who could provide motor drives. Aided by social media reports, employees from WK Dickson's Atlanta office picked up the drives and drove the rerouted course to reach the Northwest Plant. A vendor was able to provide a portable disk filter unit that arrived 10 days after the storm and enabled tertiary filtration to be restored on a long-term basis.

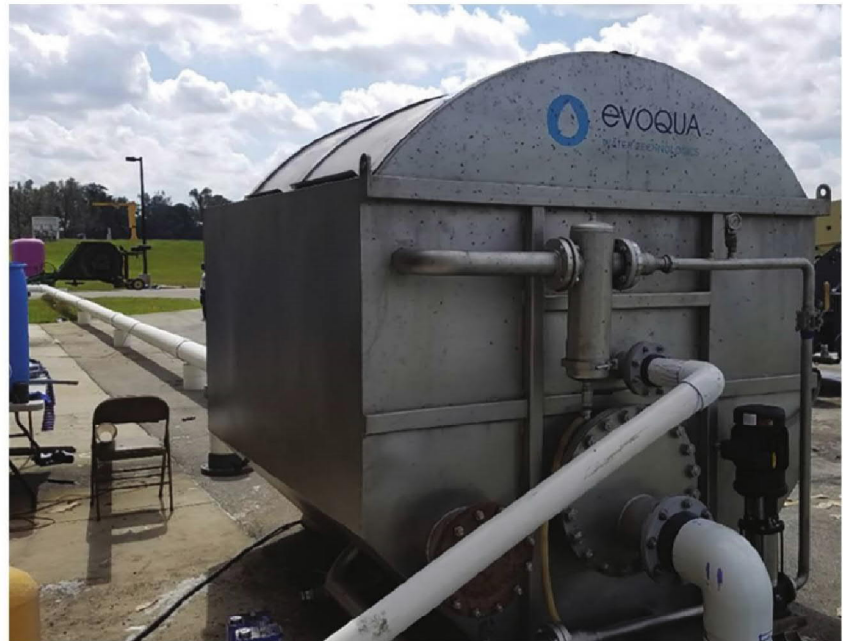
A portable disk filter unit arrived 10 days after the storm and enabled tertiary filtration to be restored on a long-term basis.
